# Teresa's Property Inspections

## SUMMARY REPORT

**Inspection Date:** 9/29/2016

**Inspected by:** Teresa Howarth

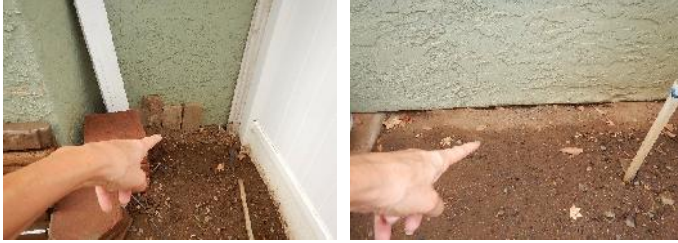
Landscaping is above foundation and touching the stucco wall - *Continued*

Landscaping is above foundation and touching the stucco wall. This allows moisture to wick into the walls.

Recommend removing landscaping to expose a minimum of 8" of the weep screed.

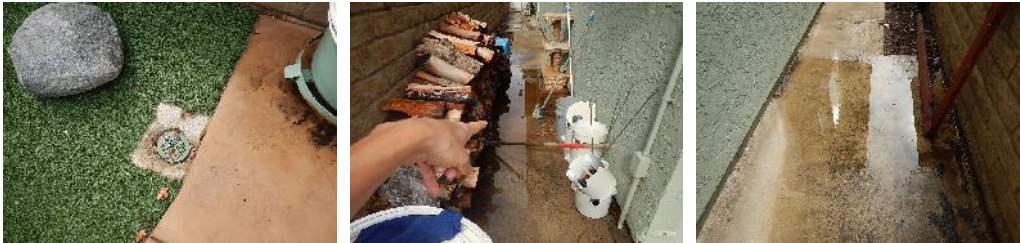
The property is served by one area drain. Because it is impossible to see inside them, the seller should guarantee that the drains are functional, or they should be flushed through to the street before the end of the inspection contingencies time frame. Other areas of the side yard have ponding which should be evaluated by a specialist to prevent moisture intrusion into the home. Surface water carries minerals and silt that is deposited inside the pipes and hardens in the summer months to the consistency of wet concrete, which can impede drainage and require the pipes to be cleared by a roter service.

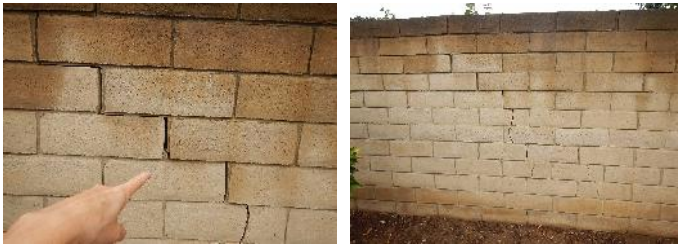
The cinder block walls have stress fractures and open grout joints and should be evaluated by a qualified brick mason before the end of the inspection contingencies timeframe.

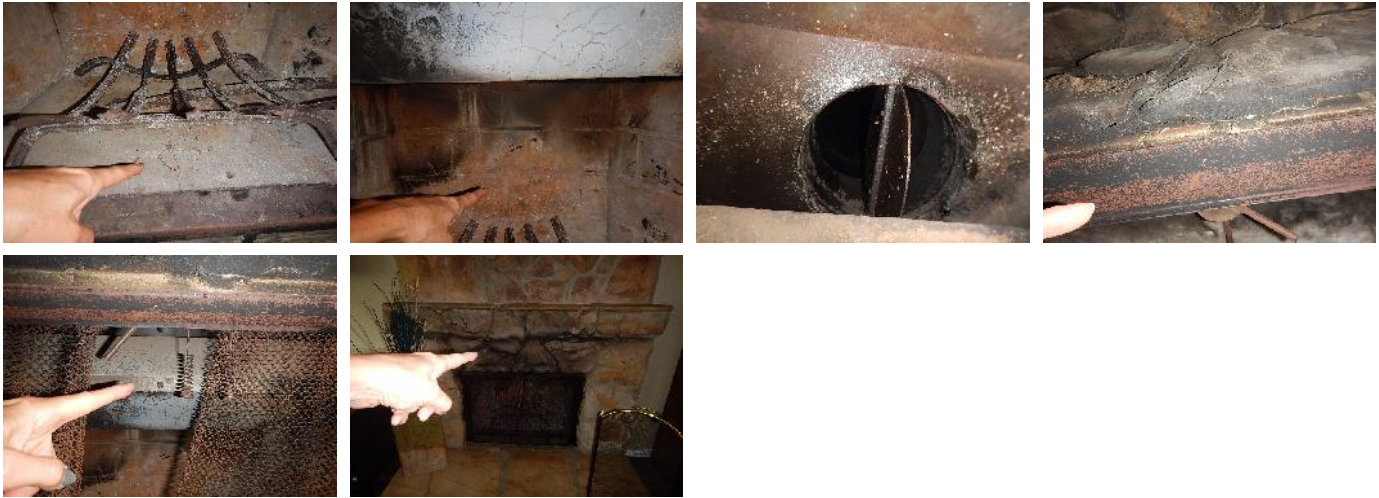
The chimney firebox is cracked, flue is dirty, rusted lintel and has smoke rollout on the front. No rain cap which allows moisture to enter the flu and it needs a damper stopper and the handle repaired for the screen. Recommend having it evaluated by a specialist prior to the close of the inspection contingencies time frame.

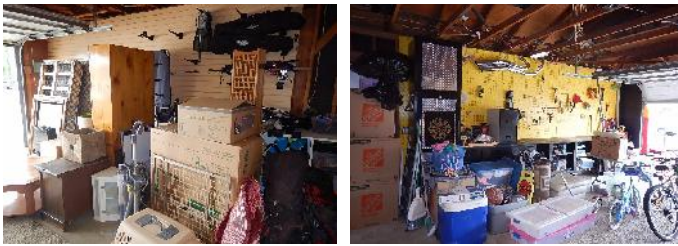
Ventilation ports cannot be seen due to personal property.

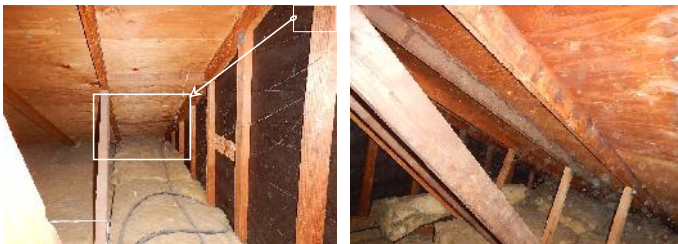
Moisture stains present. Recommend having a licensed roofer evaluate prior to the close of the inspection contingencies time frame to see if you can get a warranty on the roof.
